# South Englewood Storm Sewer Condition Assessment

*Prepared for*  
**Calibre Engineering, Inc**

*Prepared by*  
**Ingenium Engineers**  
1153 Bergen Parkway  
Suite I #278  
Evergreen, CO 80439  
(303) 908-1116

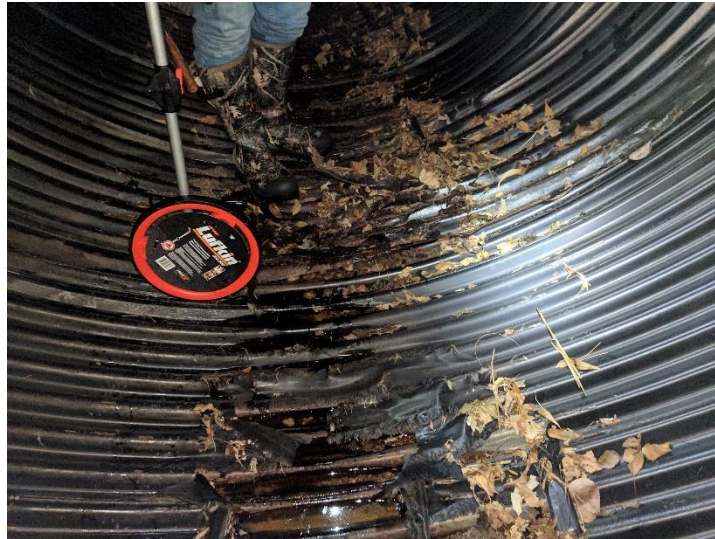
*Segment 1* – Minor coating damage approximately 20 feet in length was noted along the invert at approximate station 101+00 (Stationing is relative to the 1973 Sellards and Grigg as-built drawings).

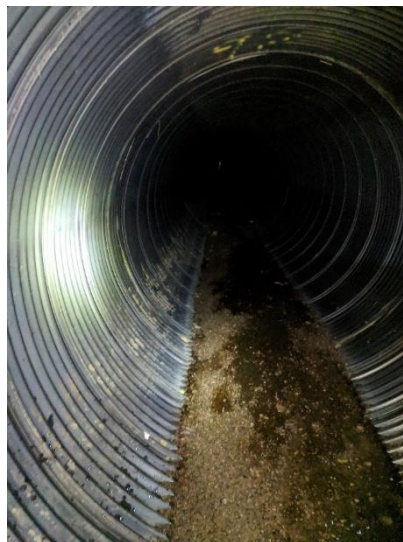
*Segment 2* – No corrosion, deformation, or invert deterioration was noted; however, there a partially opened joint at approximate station 101+58 (stationing is relative to the 1973 Sellards and Grigg as-built drawings) and there is a significant amount of sedimentation (sand and gravel) in the invert.

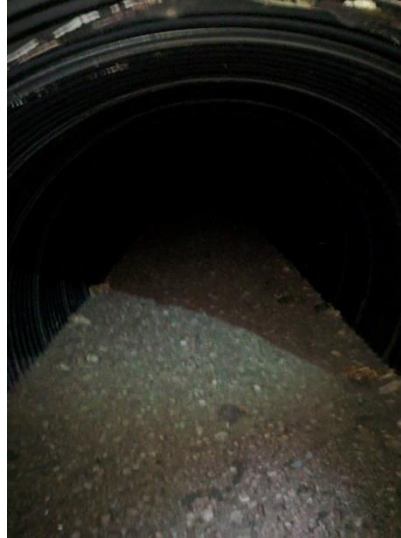
*Segment 3* – No corrosion, deformation, invert deterioration, or joint damage was noted; however, sedimentation deposits become extremely heavy and were noted as follows: Sta 108+90 Sed 17"; Sta 109+57 Sed 21"; Sta 110+25 Sed 22"; Sta 111+13 Sed 31"; Sta 111+75 Sed 32" (stationing is relative to the 1973 Sellards and Grigg as-built drawings)

*It is more than likely that the invert is severely deteriorated beneath the sedimentation*

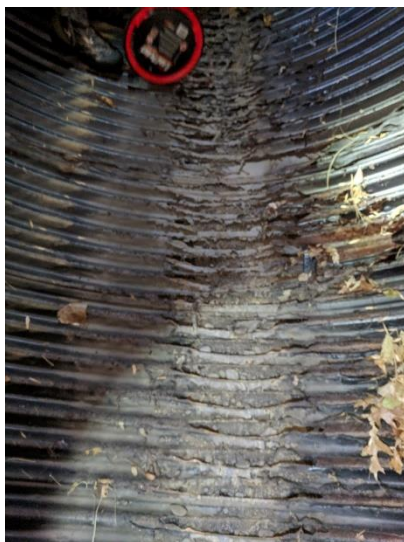
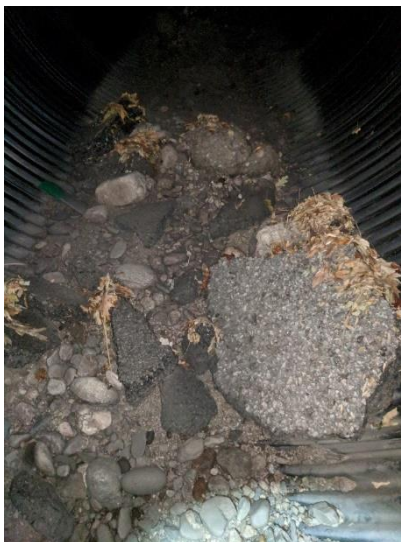
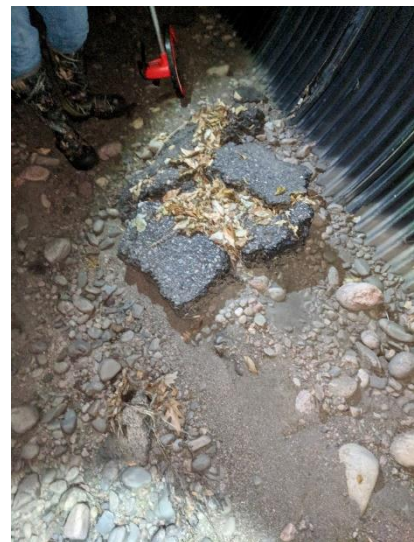
*Segment 4* – No corrosion, deformation, or joint damage was noted; however, severe invert deterioration was noted at station 118+00 and heavy sedimentation deposits and collections of debris (asphalt) were noted as follows: Sta 111+75 Sed 32"; Sta 112+21 Sed 31"; Sta 112+98 Sed 23"; Sta 114+10 Asphalt, Sed 14"; Sta 116+33 Asphalt; Sta 117+32 End asphalt deposition. (stationing is relative to the 1973 Sellards and Grigg as-built drawings).

*It is more than likely that the invert is severely deteriorated beneath the sedimentation*

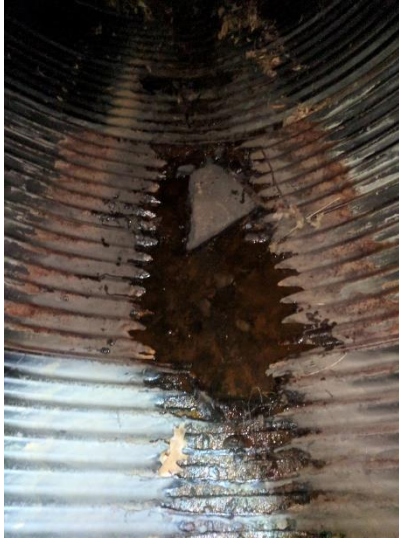
*Segment 5* - No corrosion, deformation, or joint damage was noted; however, severe invert deterioration was noted from station 118+63 to station 119+37. (Stationing is relative to the 1973 Sellards and Grigg as-built drawings).

Rehabilitation may be limited to repair of inverts only, in which case, applicable invert rehabilitation methods would include:

- Pressure grouting voids beneath the corroded invert and troweling in a flowable lean concrete to reconstruct the invert
- Pressure grout voids beneath the corroded invert, lay a concrete cloth (Concrete Canvas) over the length of corroded invert, and fasten the cloth to the exiting culvert walls with stainless steel bolts or by applying a layer of spray applied epoxy or cement mortar lining material. <https://www.youtube.com/watch?v=JUiv67WkqCY>

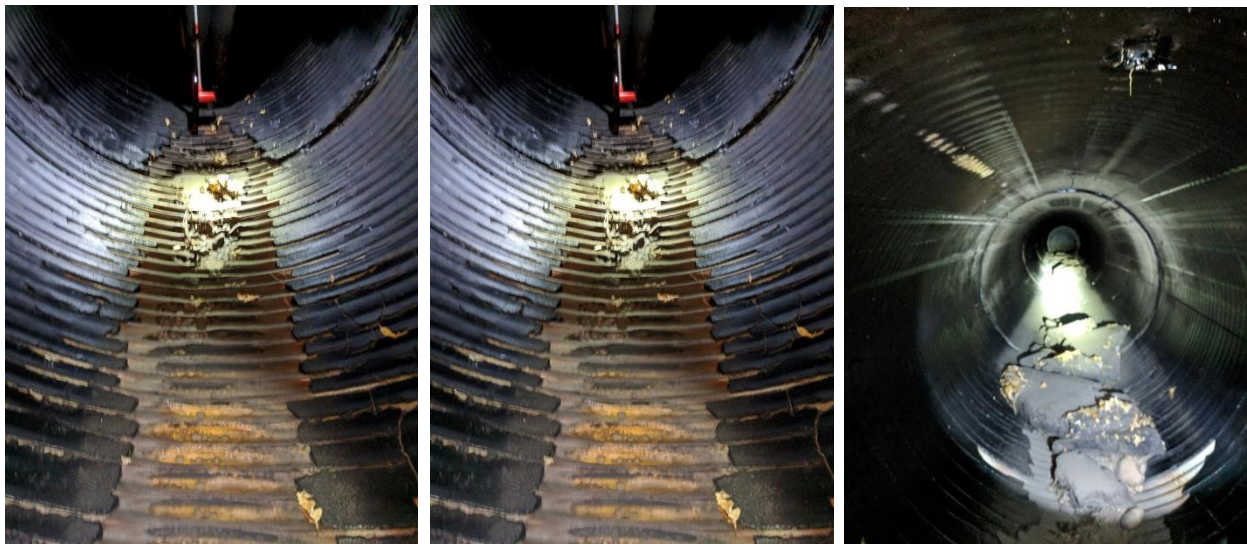
*Segment 6* - No corrosion, deformation, or joint damage was noted; however, severe invert deterioration was noted along most of the CMP sections of pipe. Some isolated areas of debris deposits were noted; asphalt.

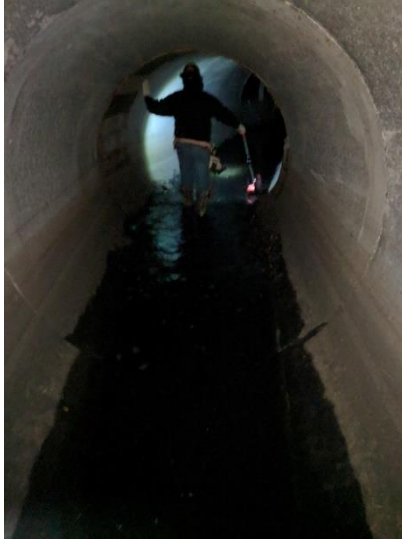
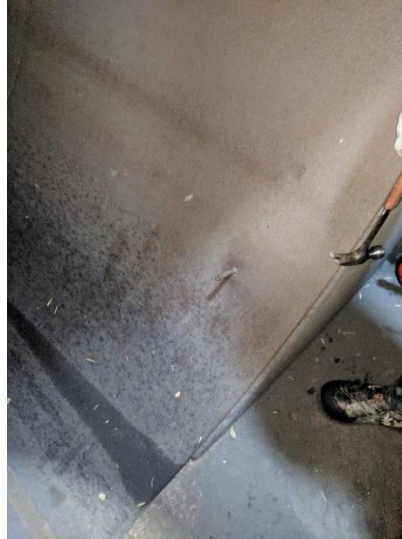
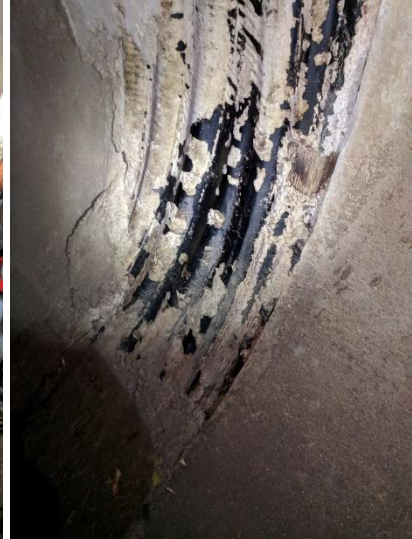
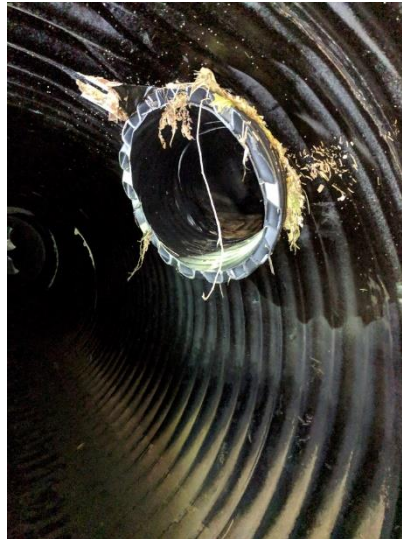
*Segment 7* – This segment includes portions of the pipeline that were realigned as part of the Santa Fe project; therefore, stationing information varies from the Sellards and Grigg drawings and is not offered as part of the evaluation. No corrosion, deformation, invert deterioration, or joint damage noted.

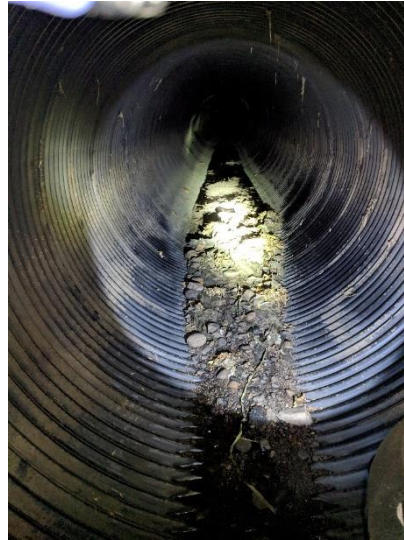
*Segment 12* – This is the first segment along Navajo Street; other than some areas of minor debris collection, no other issues were noted.

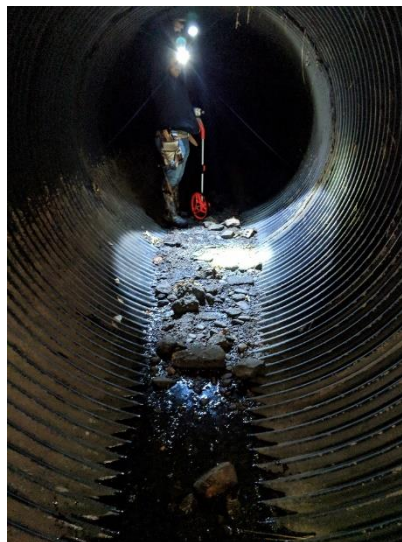
*Segment 17* – No corrosion, deformation, invert deterioration, or joint damage was noted; however, there was some areas of debris deposits from station 215+14 to 217+67. (Stationing is relative to the 1973 Sellards and Grigg as-built drawings).

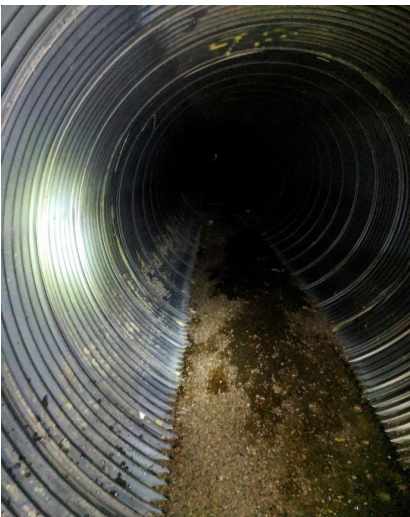
| Corrosion | | | |
|---|---|---|--|
| Invert to Springline | Sta 103+65 | | No corrosion noted - Invert covered with sedimentation (Approx 10" deep) |

| Invert Deterioration | | | |
|---|---|---|---|
| Invert | Sta 103+65 | | No deterioration noted - sedimenttion average 10" |

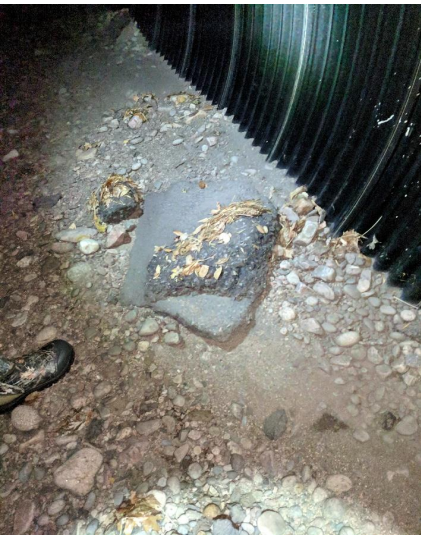
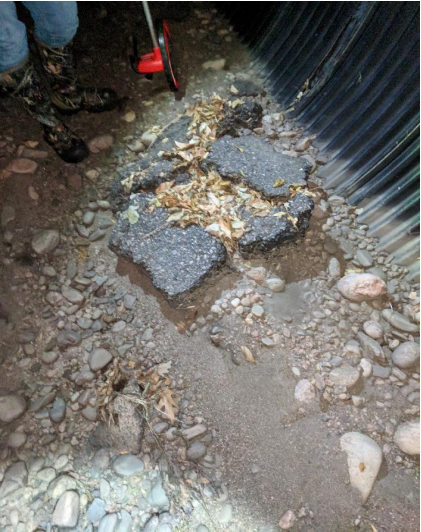
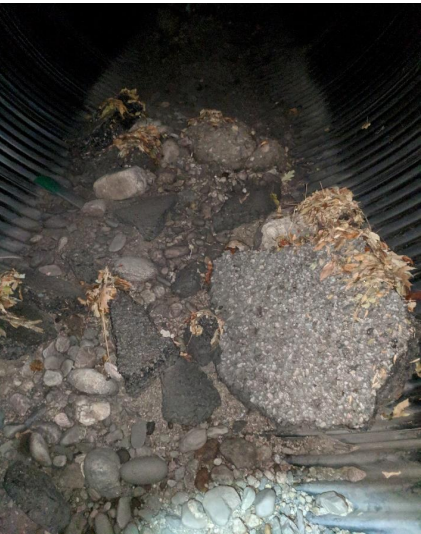
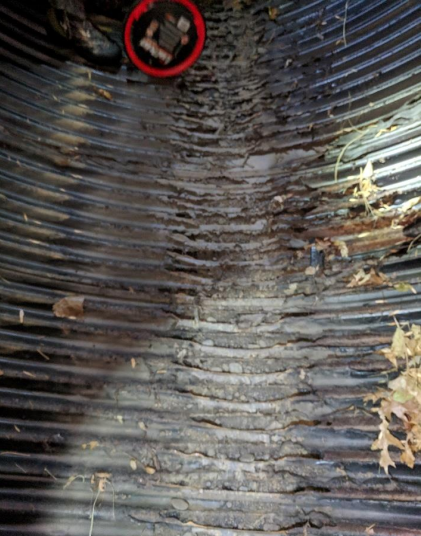
Segment 4  
Line 1

| Invert Deterioration | | | |
|---|---|---|---|
| Invert | Sta 117+32 to Sta 118+00 | 1 | Severe invert deterioration<br>Sta 111+75 Sed 32"; Sta 112+21 Sed 31";<br>Sta 112+98 Sed 23"; Sta 114+10 Asphalt, Sed 14";<br>Sta 116+33 Asphalt; Sta 117+32 End asphalt deposit,<br>Sta 118+00 Invert deterioration severe |

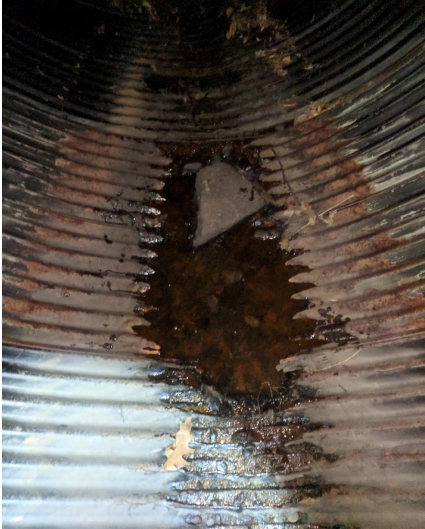
Segment 5  
Line 1

| Corrosion | | | |
|---|---|---|---|
| Invert to Springline | 118+63 to 119+37 | 1 | Severe invert corrosion |

| Invert Deterioration | | | |
|---|---|---|--|
| Invert | 118+63 to 119+37 | 1 | Severe invert corrosion; bedding exposed |
