Field Notes and Photographs

City of Englewood, Colorado
 South Englewood Storm Sewer Condition Assessment
 Field Data Sheets - Line 1 and Line 2

Client: City of Englewood, Colorado
 Project: South Englewood Storm Drain Condition Assessment
 Date: 11/11/2018

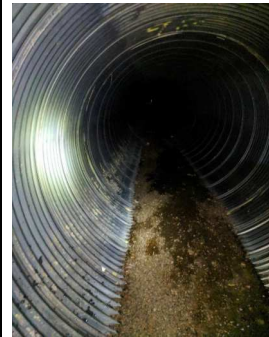
**Segment 2
Line 1**

Corrosion			
Location	Approx. Sta	Rating 1 - 3	Notes
Invert to Springline	Sta 103+65		No corrosion noted - Invert covered with sedimentation (Approx 10" deep)
Springline to Crown			No corrosion noted - CMP in excellent condition
Crown			No corrosion noted - CMP in excellent condition

Invert Deterioration			
Location	Approx. Sta	Rating 1 - 3	Notes
Invert	Sta 103+65		No deterioration noted - sedimentation average 10"

Joints and Seams			
Location	Approx. Sta	Rating 1 - 4	Notes
Joints and Seams	101+58	4	Sta 101+58 - slight separation

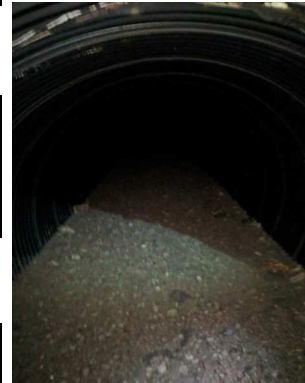
**Segment 3
Line 1**

Invert Deterioration			
Location	Approx. Sta	Rating 1 - 3	Notes
Invert			No deterioration noted; Sta 108+90 Sed 17"; Sta 109+57 Sed 21"; Sta 110+25 Sed 22"; Sta 111+13 Sed 31"; Sta 111+75 Sed 32"

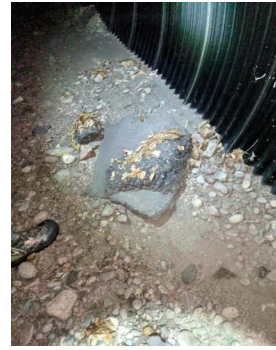
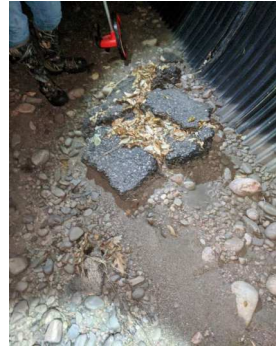
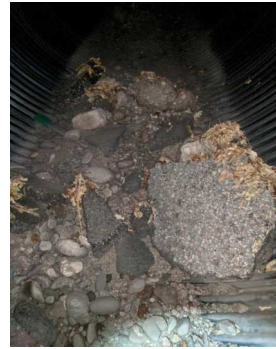
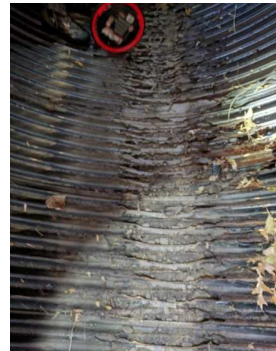
**Segment 4
Line 1**

Invert Deterioration			
Location	Approx. Sta	Rating 1 - 3	Notes
Invert	Sta 117+32 to Sta 118+00	1	Severe invert deterioration Sta 111+75 Sed 32"; Sta 112+21 Sed 31"; Sta 112+98 Sed 23"; Sta 114+10 Asphalt, Sed 14"; Sta 116+33 Asphalt; Sta 117+32 End asphalt deposit, Sta 118+00 Invert deterioration severe

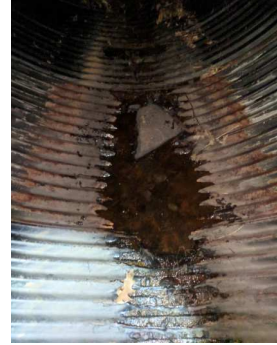
**Segment 5
Line 1**

Corrosion			
Location	Approx. Sta	Rating 1 - 3	Notes
Invert to Springline	118+63 to 119+37	1	Severe invert corrosion
Springline to Crown			No corrosion noted
Crown			No corrosion noted

Invert Deterioration			
Location	Approx. Sta	Rating 1 - 3	Notes
Invert	118+63 to 119+37	1	Severe invert corrosion; bedding exposed

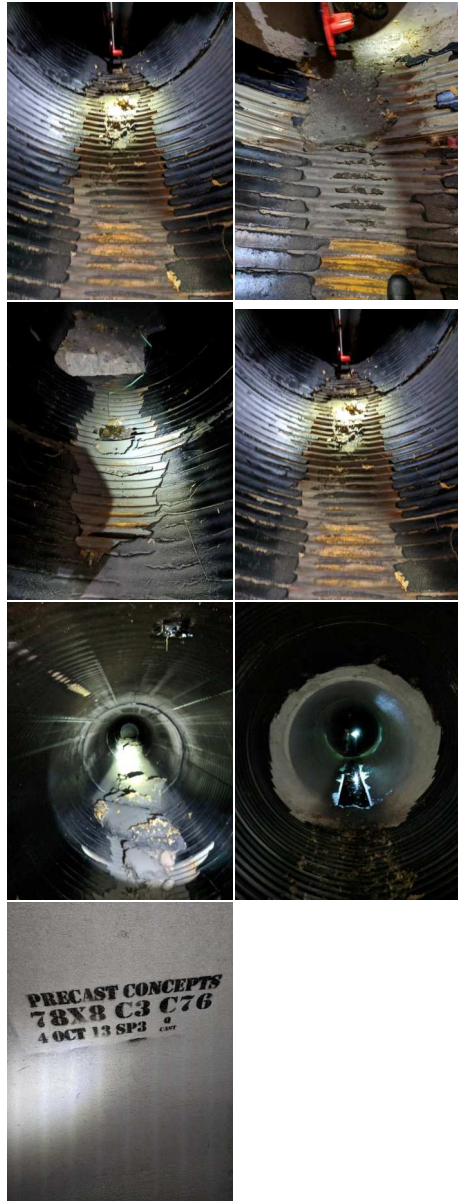
**Segment 6
Line 1**

Corrosion			
Location	Approx. Sta	Rating 1 - 3	Notes
Invert to Springline	119+75		No corrosion noted Transition missing grout
Springline to Crown			No corrosion noted
Crown			No corrosion noted

Invert Deterioration			
Location	Approx. Sta	Rating 1 - 3	Notes
Invert			Heavy invert corrosion noted, isolates areas of debris in CMP sections

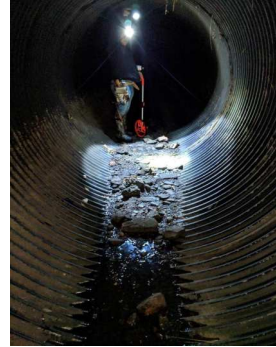
**Segment 17
Line 2**

Invert Deterioration			
Location	Approx. Sta	Rating 1 - 3	Notes
Invert	215+14 to 217+67		No deterioration noted; debris from Sta 215+14 to Sta 217+67
