# South Englewood Storm Sewer Condition Assessment

*Prepared for*  
**Calibre Engineering, Inc**

*Prepared by*  
**Ingenium Engineers**  
1153 Bergen Parkway  
Suite I #278  
Evergreen, CO 80439  
(303) 908-1116

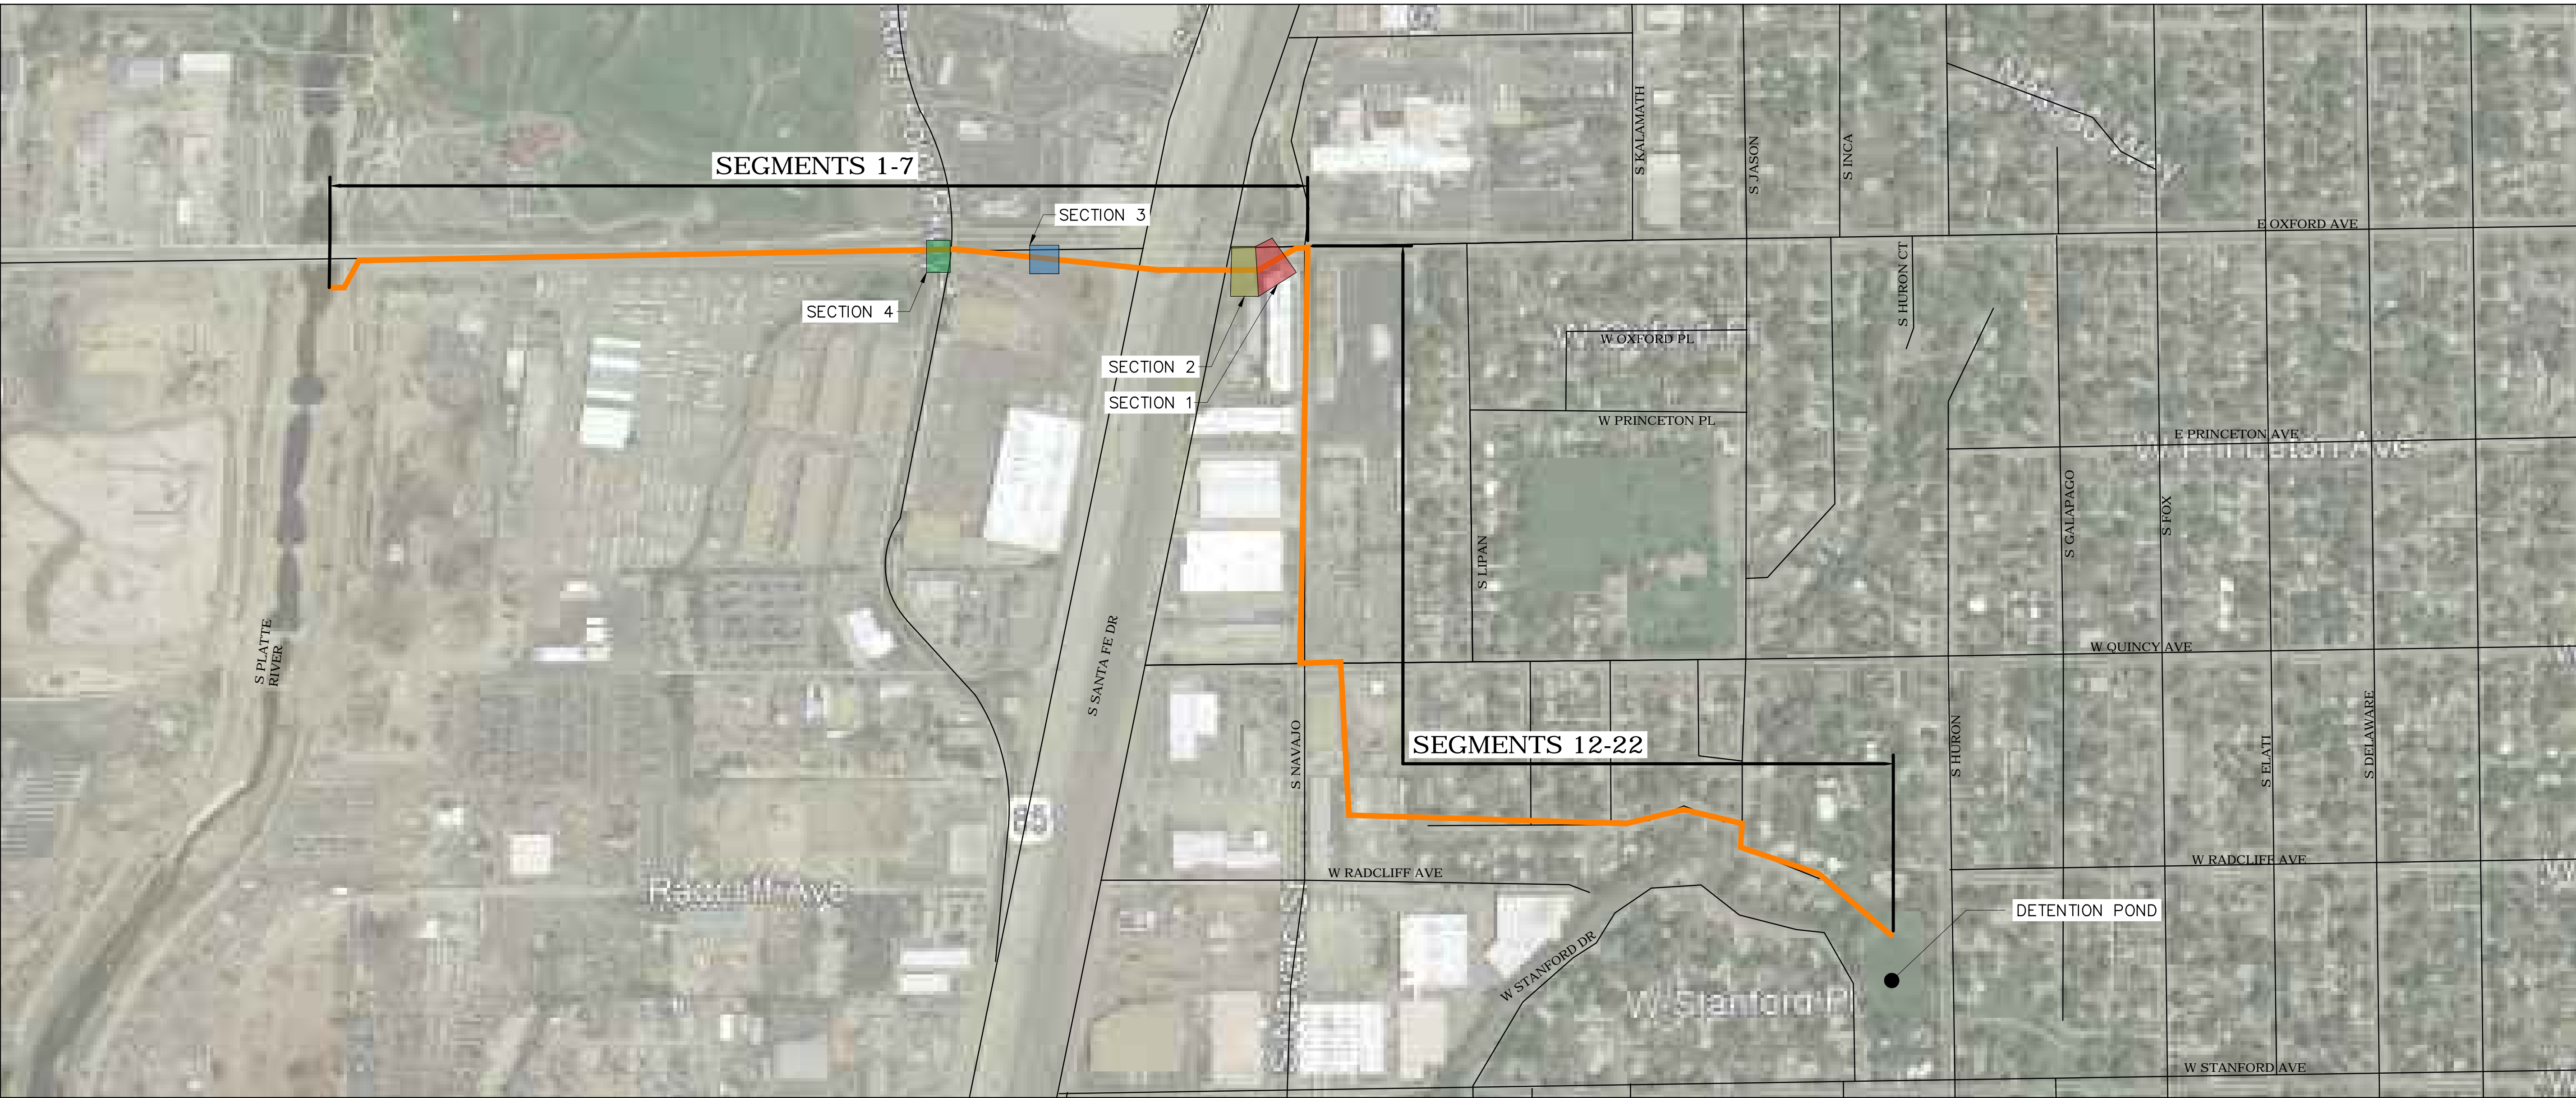
## Figure 1 – Storm Sewer Alignment and Segments

- SECTION 1: 72 LF OF 78" RCP
- SECTION 2: 76 LF OF 78" RCP
- SECTION 3: 56 LF OF 78" RCP
- SECTION 4: 56 LF OF 92" RCP
