Field Notes and Photographs

City of Englewood, Colorado
 South Englewood Storm Sewer Condition Assessment
 Field Data Sheets - Line 1 and Line 2

Client: City of Englewood, Colorado
 Project: South Englewood Storm Drain Condition Assessment
 Date: 11/11/2018

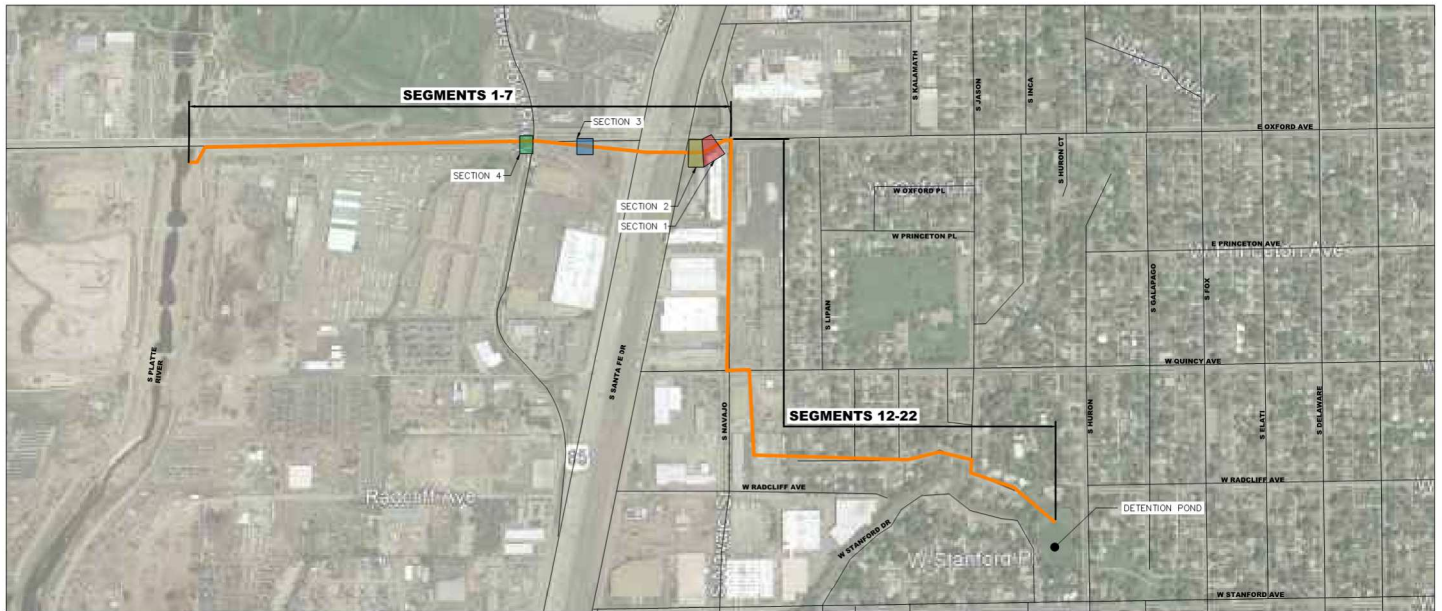
FIGURE 1: STORM SEWER ALIGNMENT AND SEGMENTS
SCALE: N.T.S.

- SECTION 1: 72 LF OF 78" RCP
- SECTION 2: 76 LF OF 78" RCP
- SECTION 3: 56 LF OF 78" RCP
- SECTION 4: 56 LF OF 92" RCP

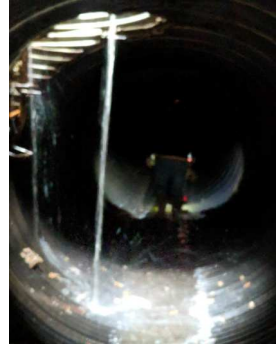
Segment 13
Line 2

Material: CMP
Diameter: 84 in.
Station: 204+25
Length: 453 ft. Station: 208+78

Corrosion			
Location	Approx. Sta	Rating 1 - 3	Notes
Invert to Springline			No corrosion noted
Springline to Crown			No corrosion noted
Crown			No corrosion noted

Deformation			
Location	Approx. Sta	Rating 1 - 3	Notes
Invert to Springline			No deformation noted
Springline to Crown			No deformation noted

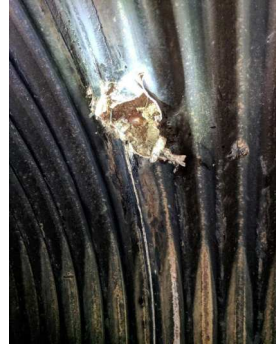
Material: CMP
Diameter: 84 in.
Station: 208+78
Length: 410 ft. Station: 212+88

Corrosion			
Location	Approx. Sta	Rating 1 - 3	Notes
Invert to Springline			No corrosion noted
Springline to Crown			No corrosion noted
Crown			No corrosion noted

Deformation			
Location	Approx. Sta	Rating 1 - 3	Notes
Invert to Springline			No deformation noted
Springline to Crown			No deformation noted
